**MONITORING RESULTS FROM THE FIELD PILOT STUDY
OF IN SITU CAPPING OF PALOS VERDES SHELF
CONTAMINATED SEDIMENTS
(Part 2 of 2)**

July 2002

Science Applications International Corporation
Admiral's Gate
221 Third Street
Newport, RI 02840
SAIC Report Number 514

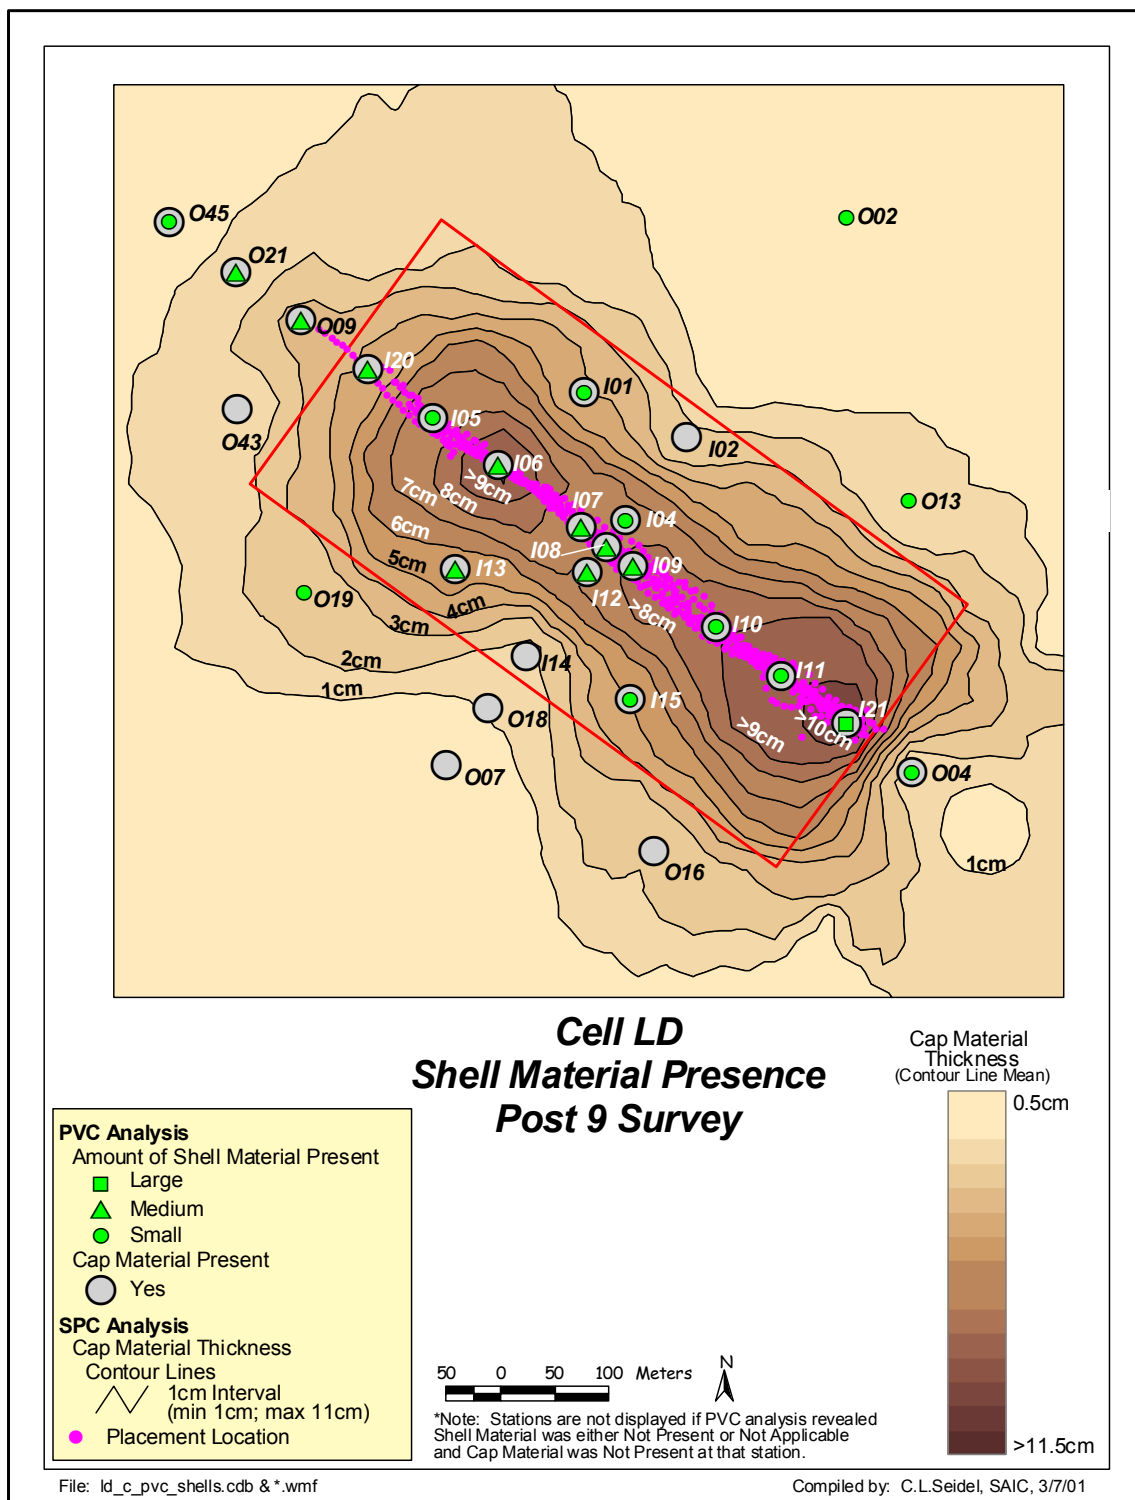
Figure 5.8-6. Lateral extent of cap material based on plan view image (PVI) analysis – Post 9 survey. The plan view image data are overlain on the SPI cap material footprint.

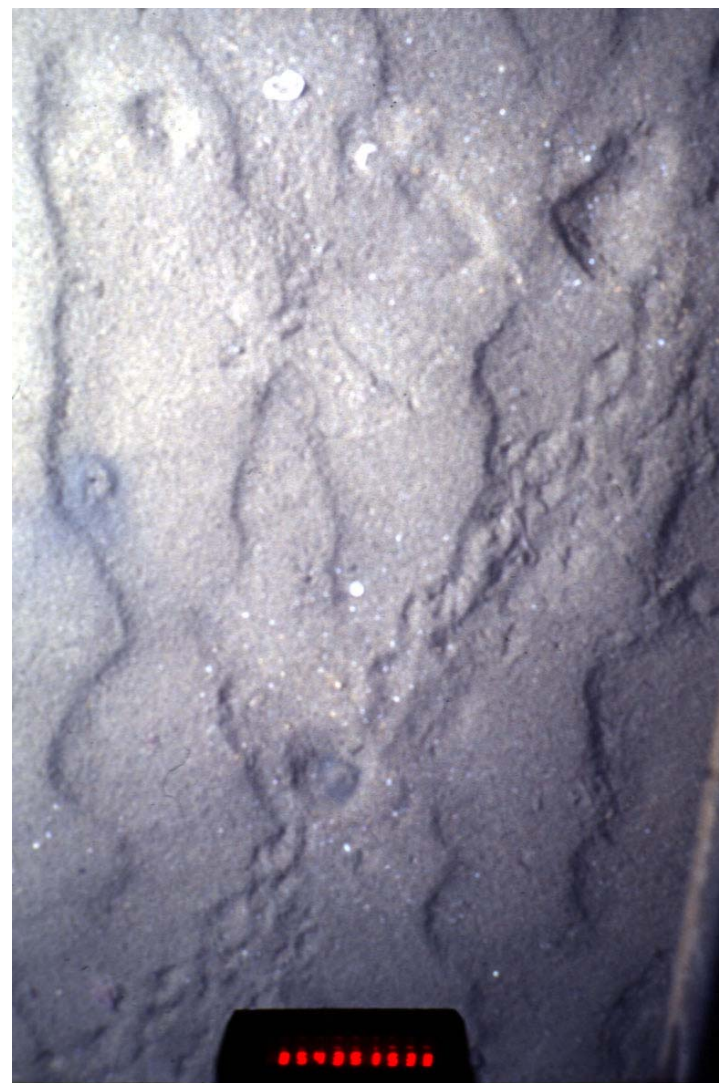
Figure 5.8-7. Re-excavated burrows. These images taken at Stations I05 and I11D during the Post 9 survey shows the re-excavation of biological burrows, denoted by patches of gray EA sediments overlying golden sand cap material.

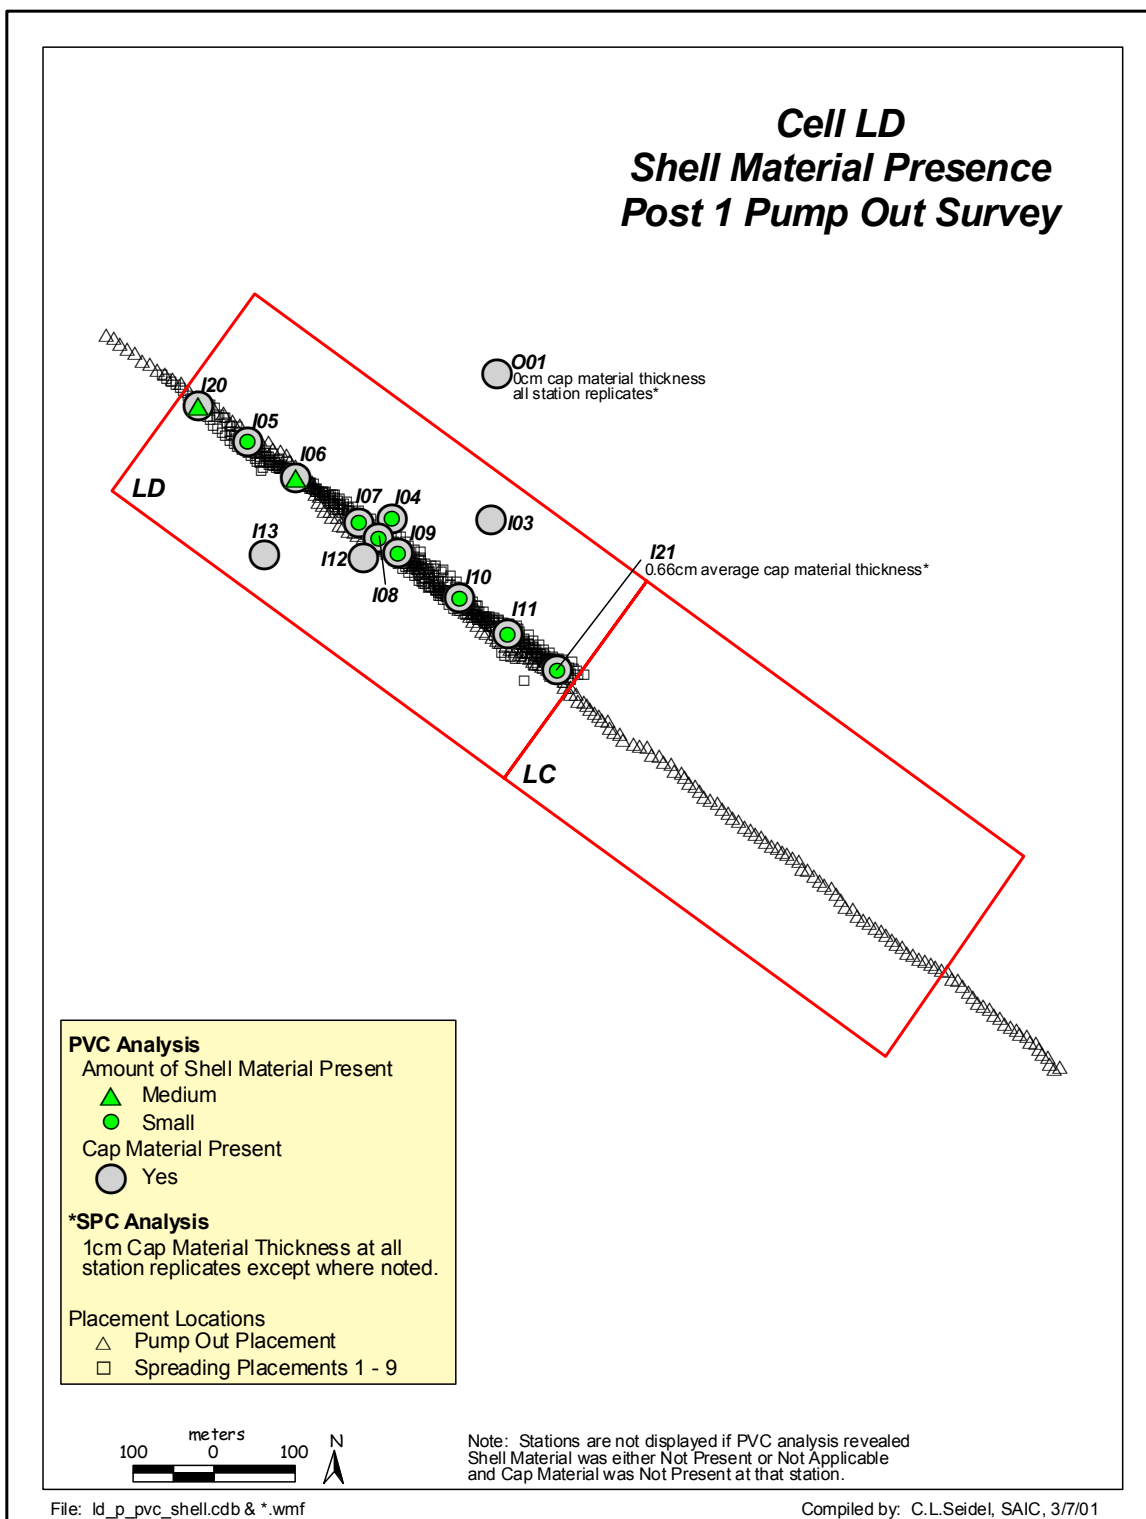
Figure 5.8-9. Lateral extent of cap material based on plan view image (PVI) analysis – Post 1 supplemental survey.

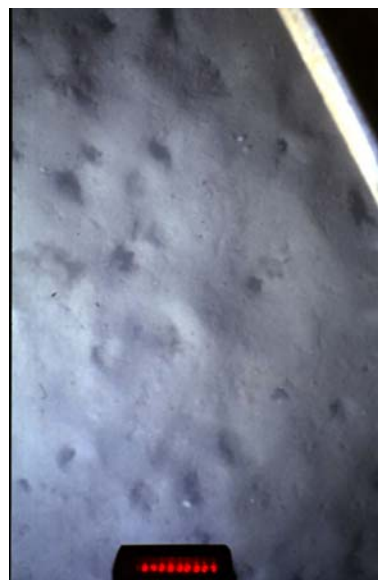
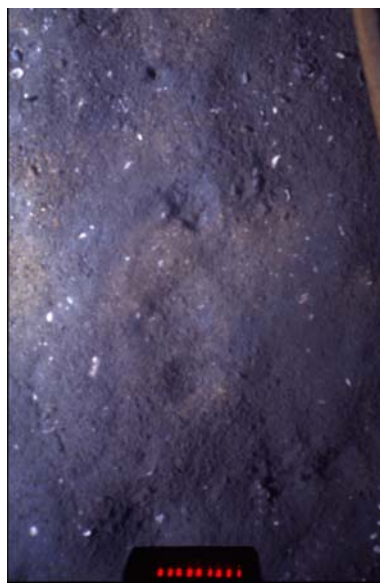
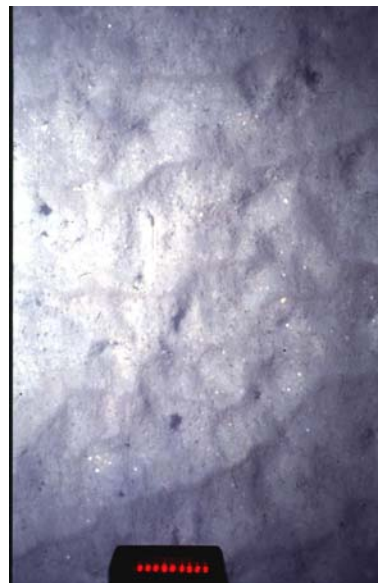
Figure 5.8-11. Temporal comparison between Cell LD Station I05 plan view images acquired during the Background, Post 9, Post 1 Pump Out and Supplemental surveys. In the images the transition between background conditions (gray sand with biological burrows), capped conditions (golden sand and golden sand mixed with Queen's Gate material) and the apparent reversion back to conditions similar to background (Supplemental Survey) can be seen. This transition may be attributed to the lateral movement of adjacent EA sediments over the top of the cap material. Also note the re-excavated burrows and sand ripples that can be seen in the Supplemental survey image, suggesting that the sediment surface is being re-worked by biological organisms as well as physical processes such as bottom currents.

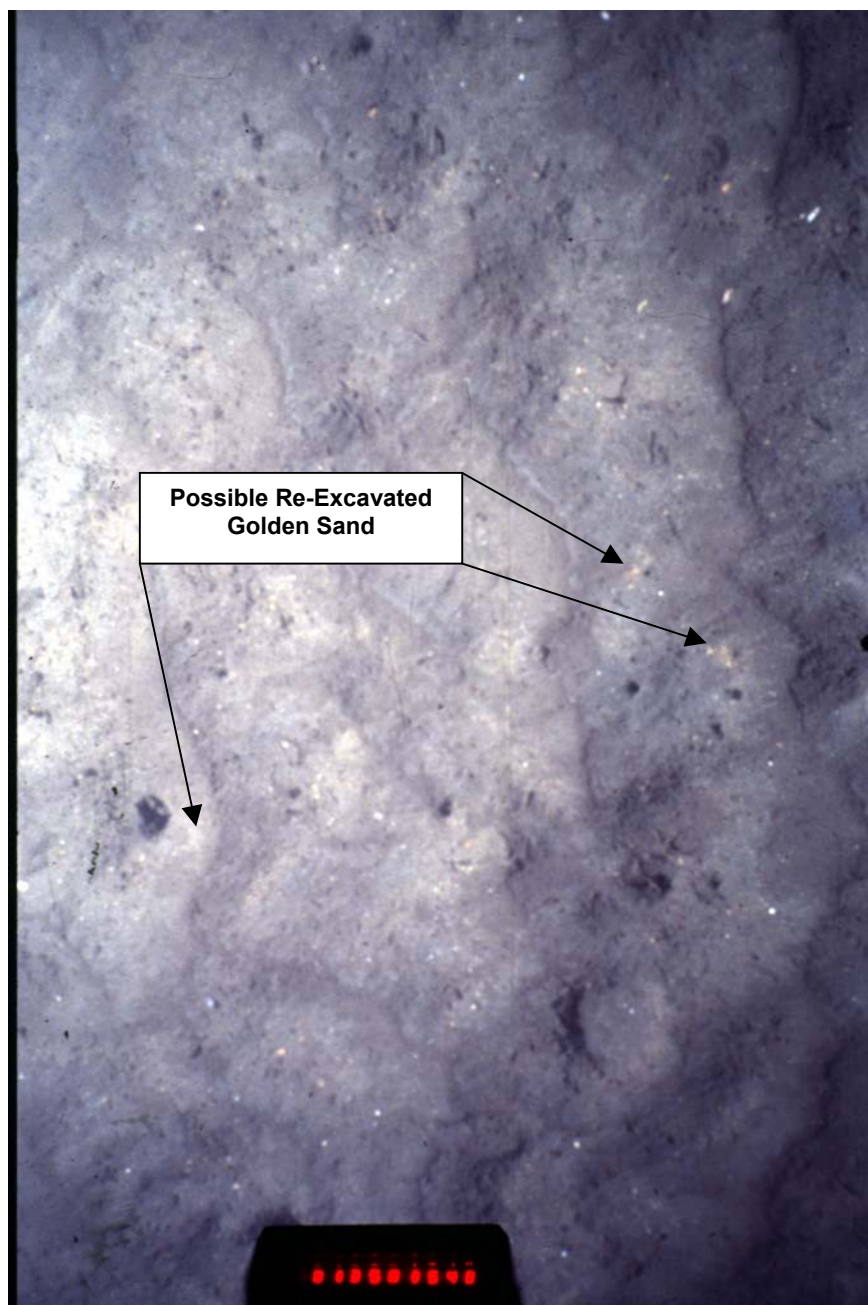
Figure 5.8-12. Plan view image acquired at Cell LD Station I08 showing a trace amount of golden sand (cap material) near the entrances of some of the biological burrows. This evidence suggests that the burrows are being re-excavated by the organisms below.

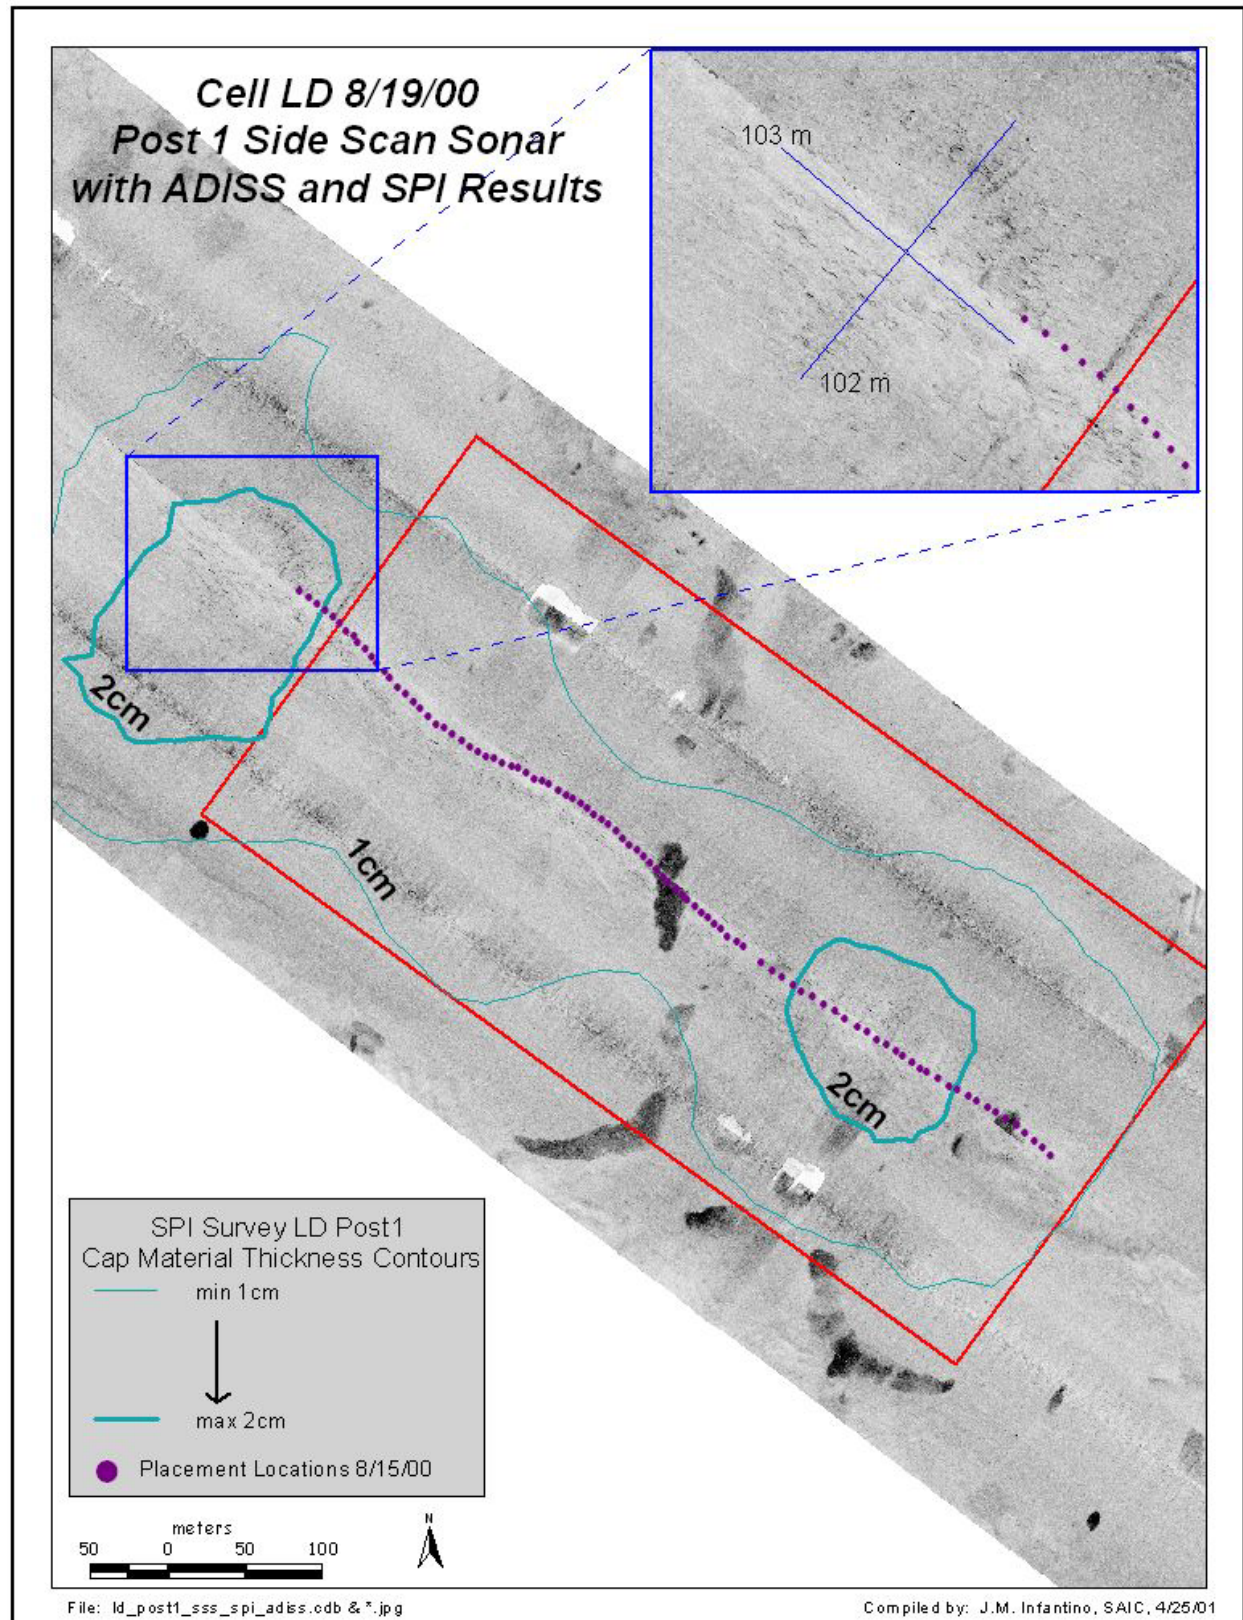
Figure 5.10-1. Side-Scan Mosaic with SPI Cap Contours and ADISS track - LD Post 1.

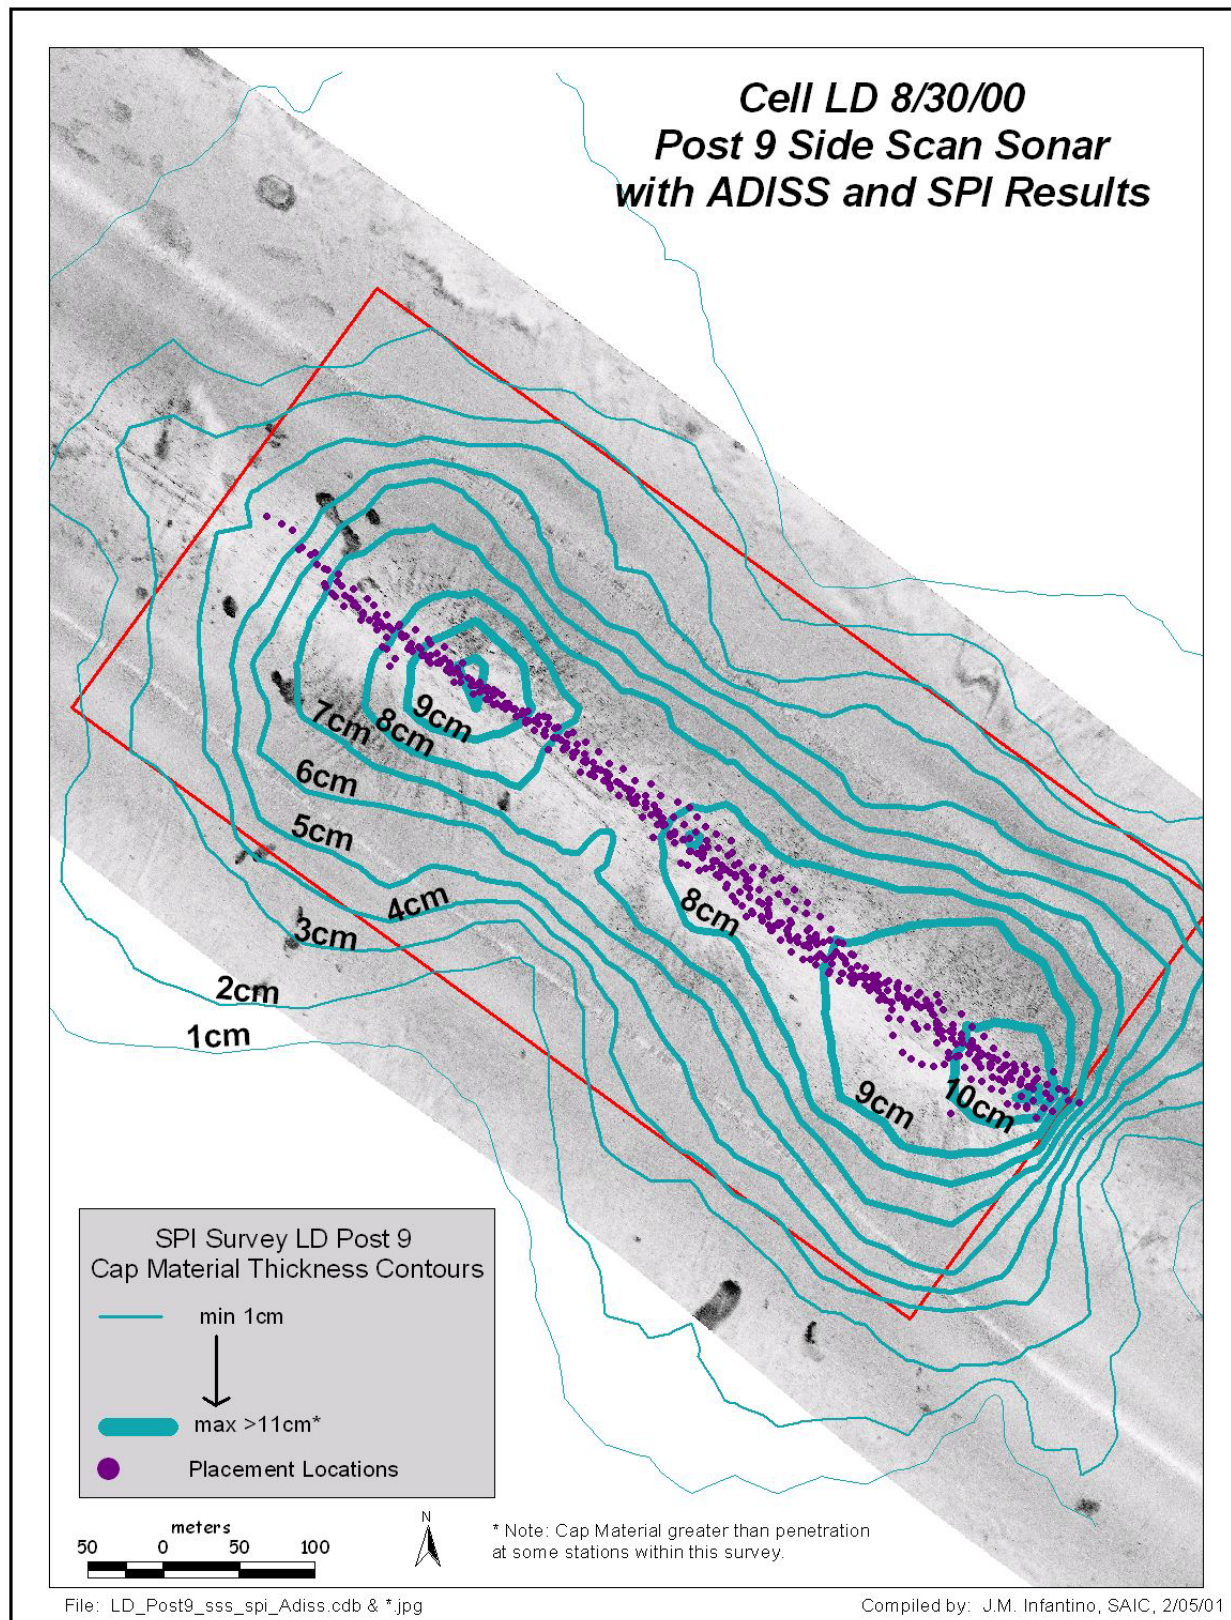
Figure 5.10-2. Side-Scan Mosaic with SPI Cap Contours and ADISS track - LD Post 9.

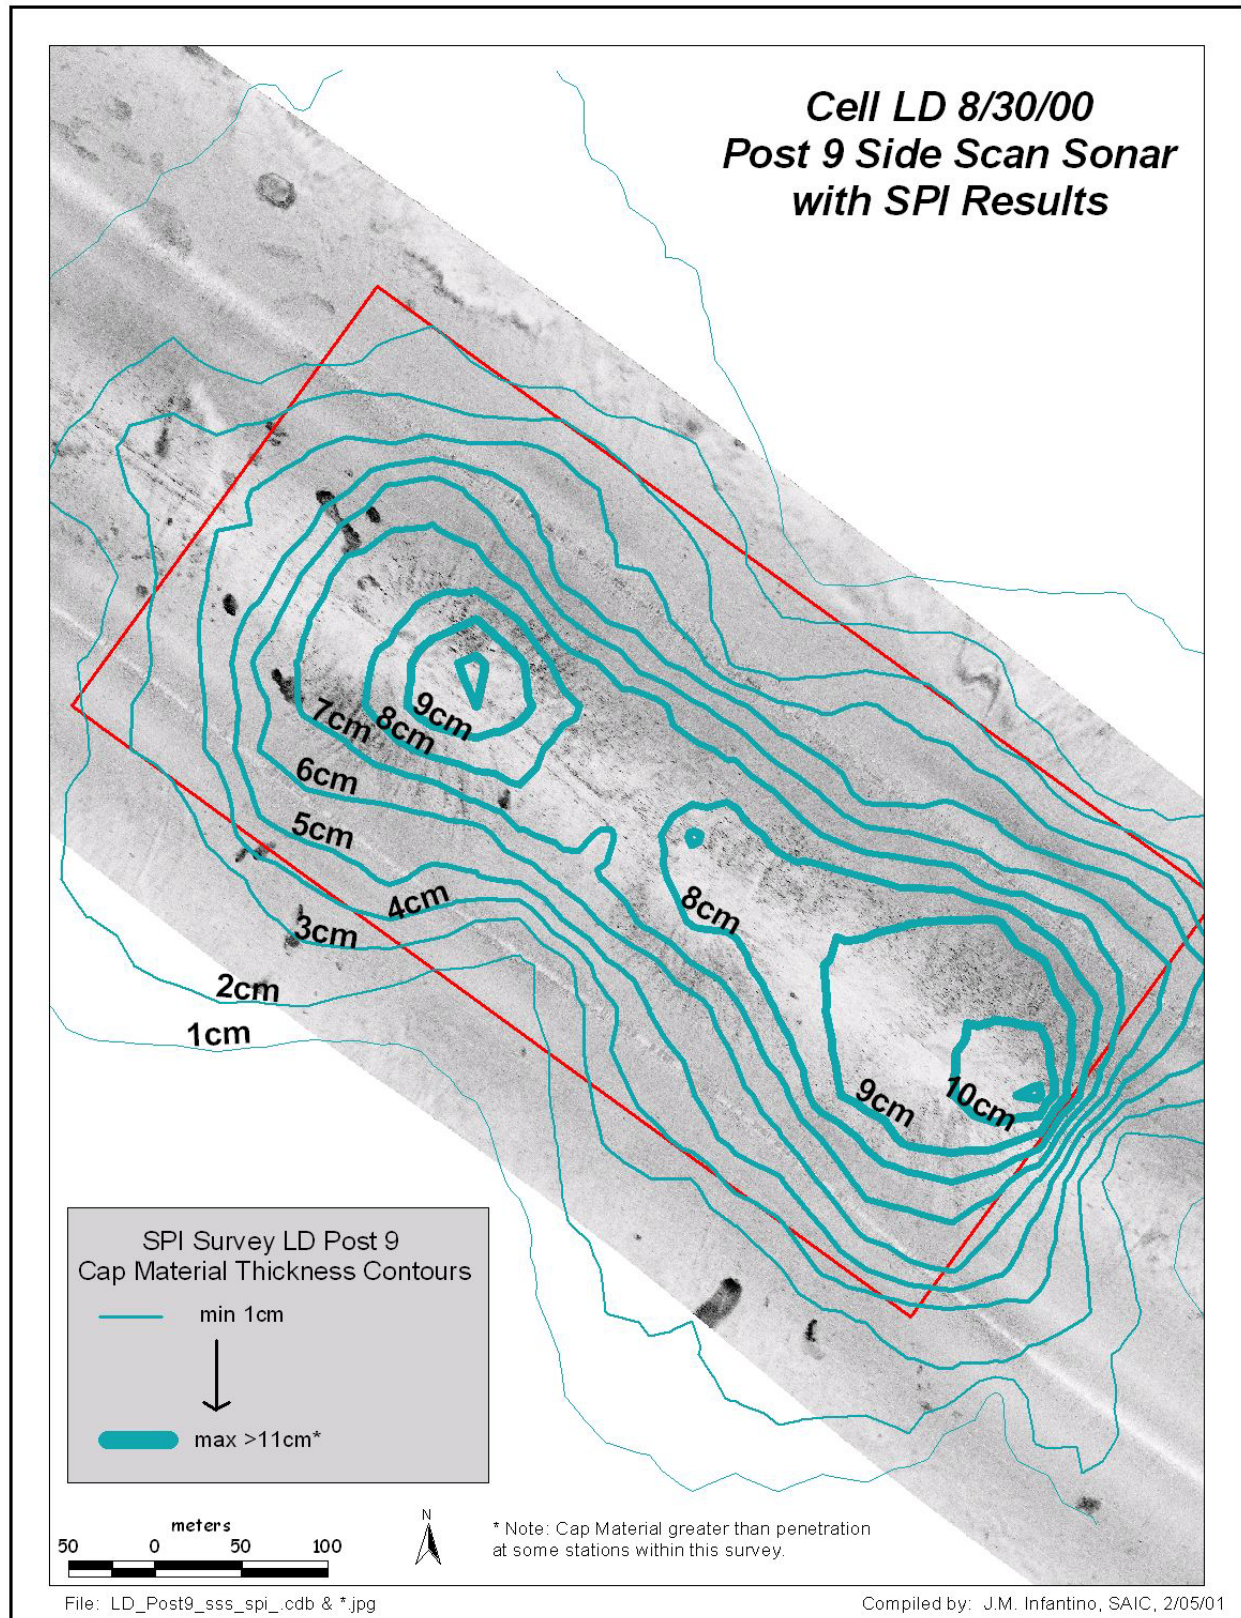
Figure 5.10-3. Side-Scan Mosaic w/SPI Cap Contours - LD Post 9.

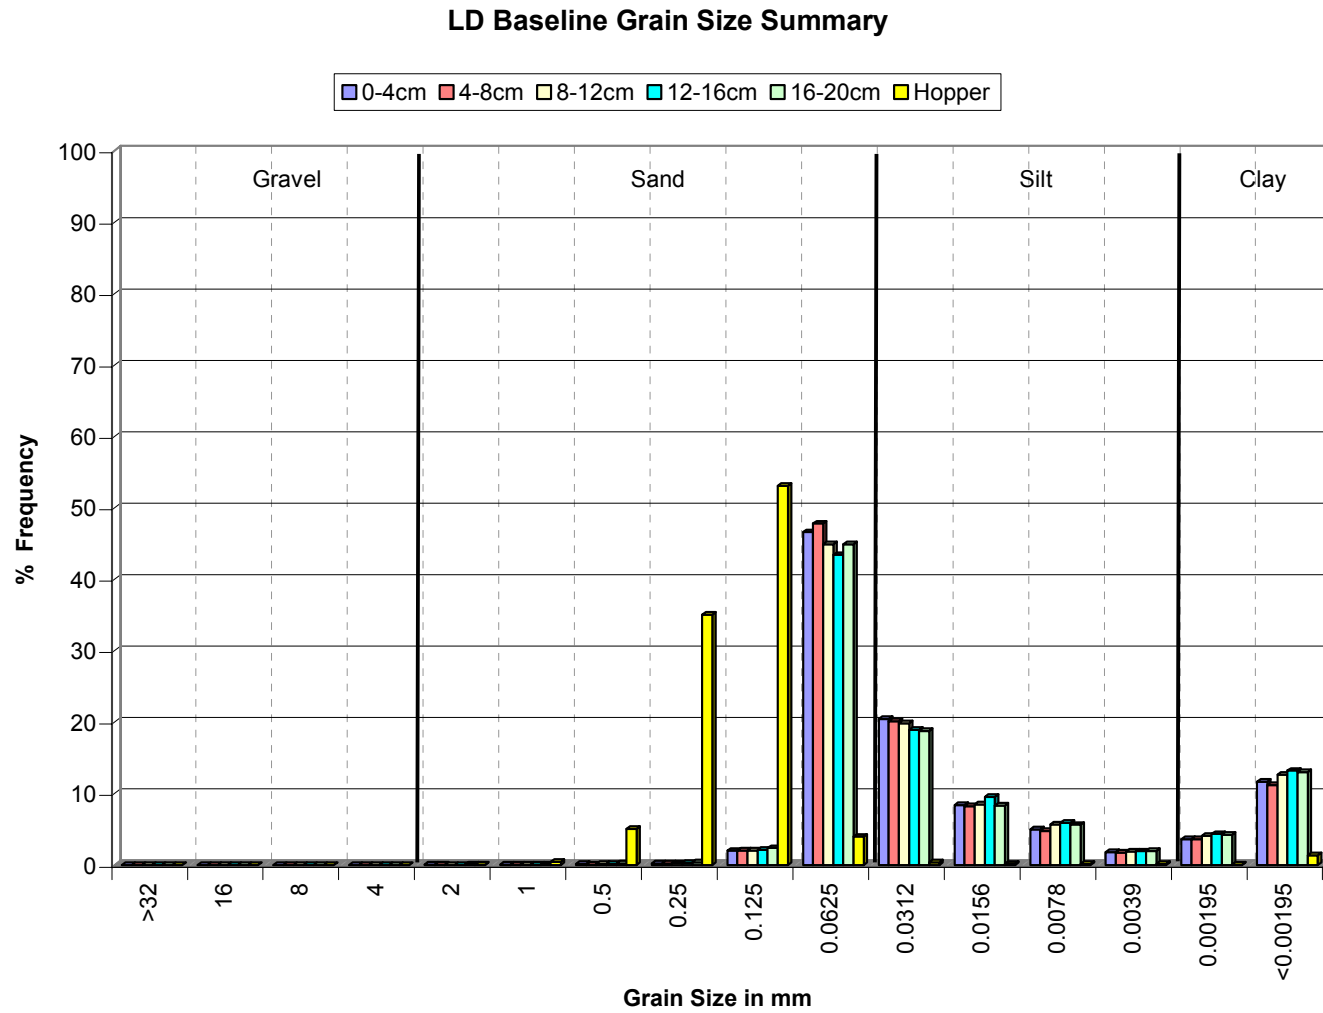
Figure 5.11-3. Grain size distributions of Cell LD baseline sediments.

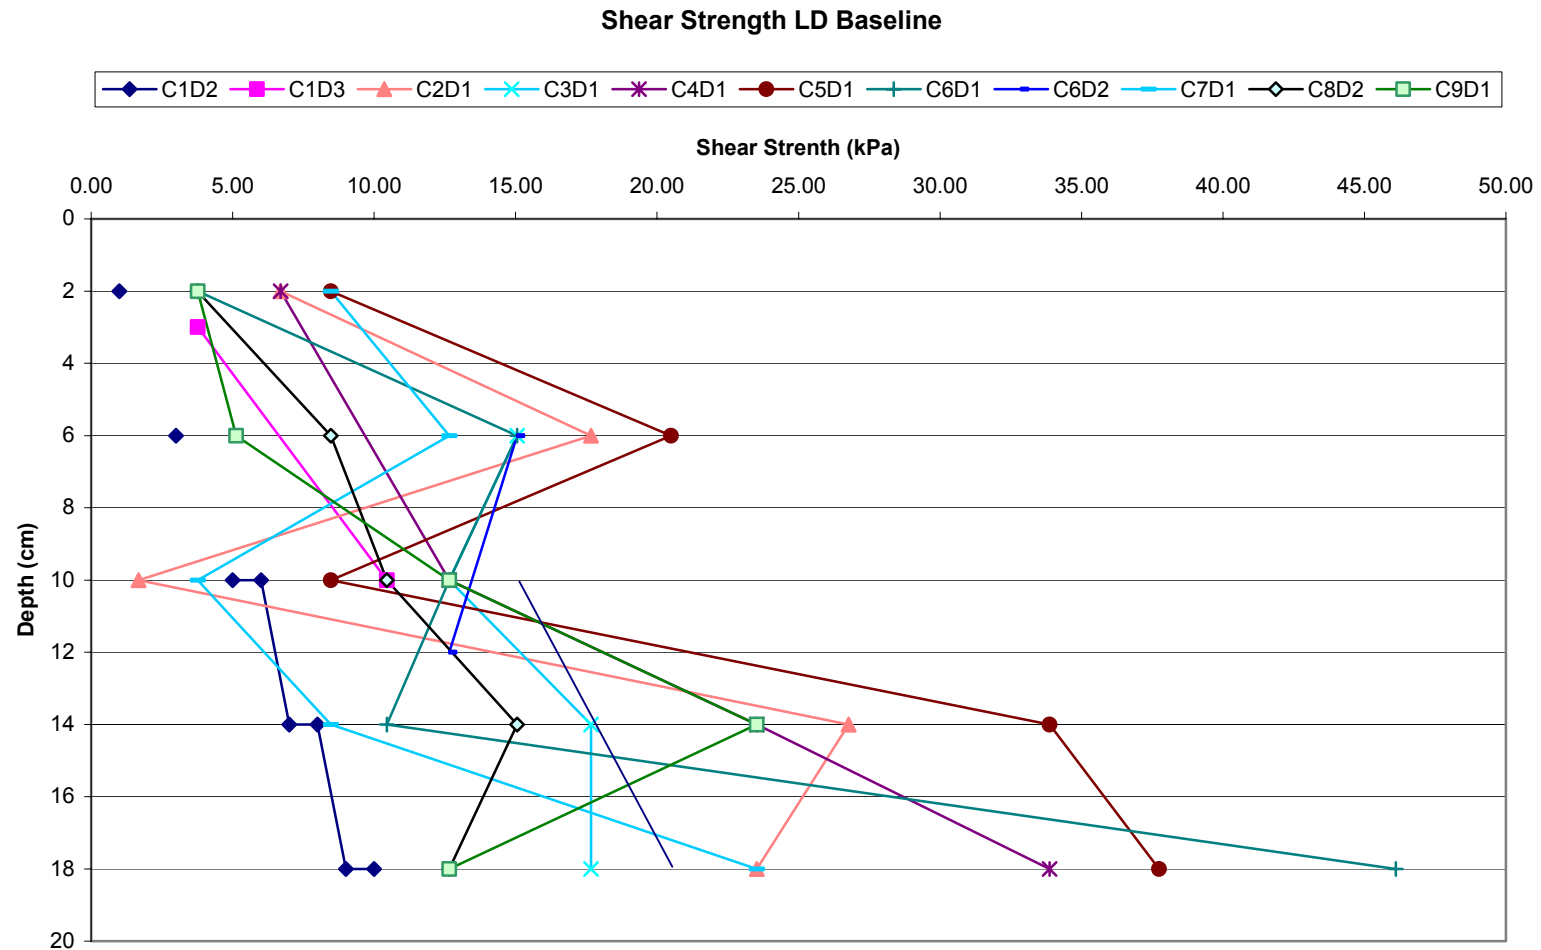
Figure 5.11-4. Profiles of shear strength values in baseline cores from Cell LD.

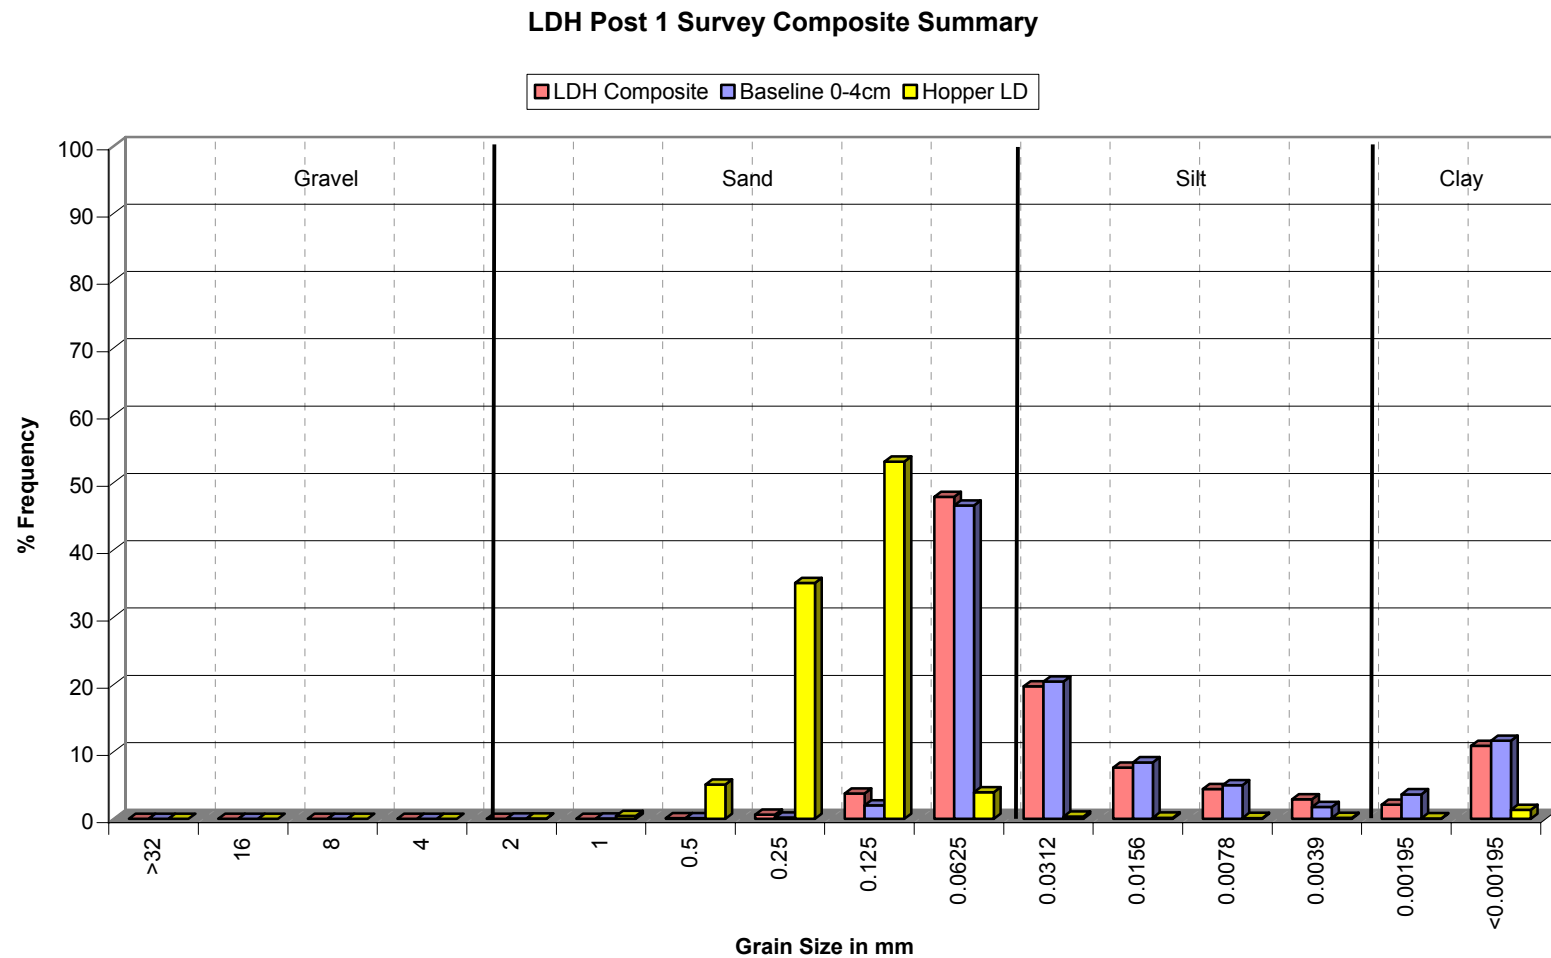
Figure 5.11-5. Grain size distributions of Cell LD Post 1 Composite Sediments.

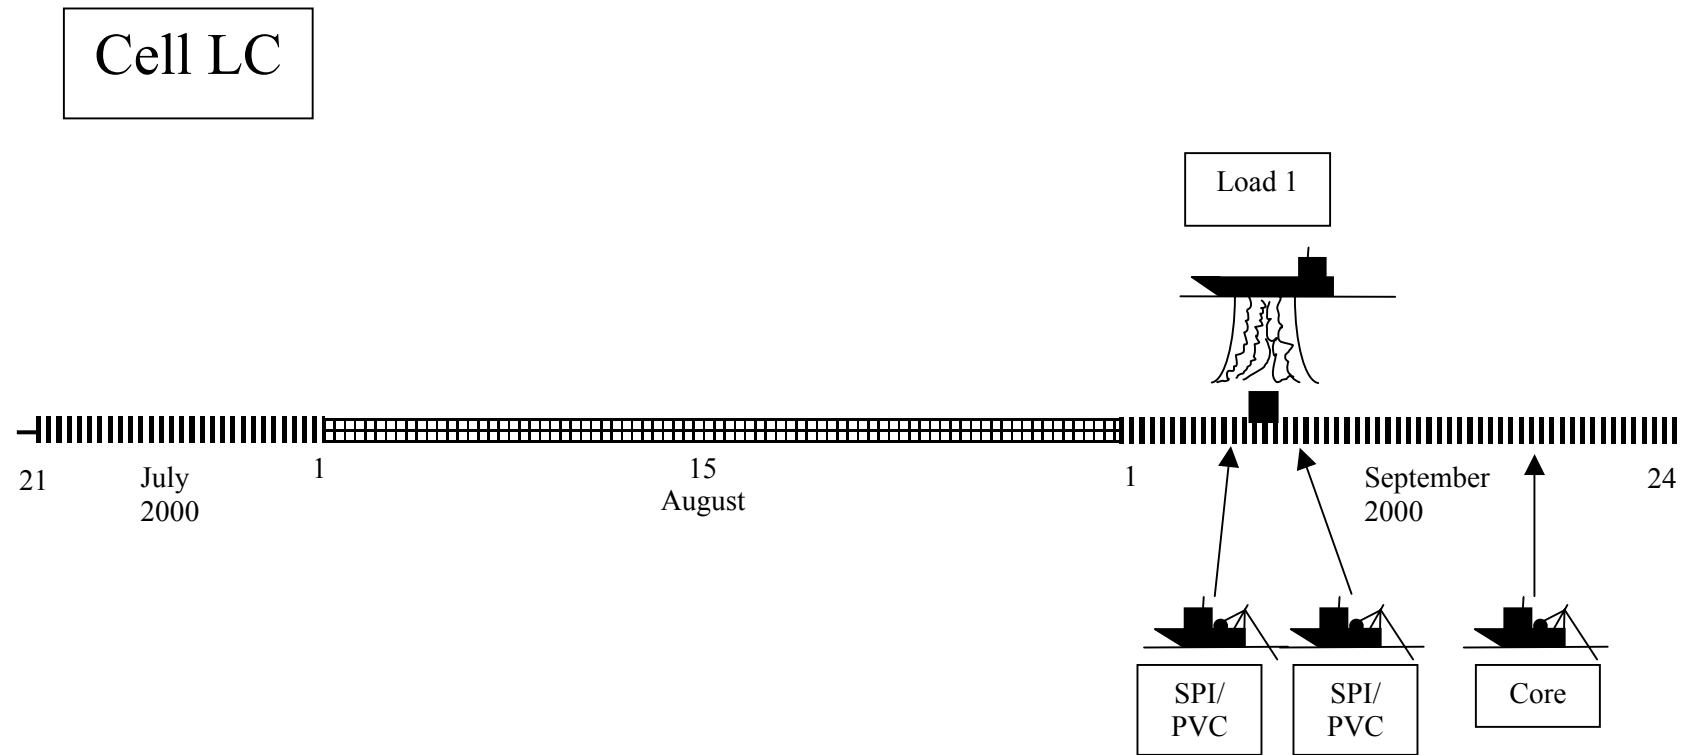
Figure 6.1-1. Activities timeline for Cell LC 21 July 2000-24 September 2000. Cap placement activity is indicated by the dredge symbol and solid bar. Monitoring activities are shown by the research vessel. Monitoring activity codes associated with the research vessel symbol are SPI-Sediment Profile Imaging, PVC-Plan View Camera, Core-Coring survey.

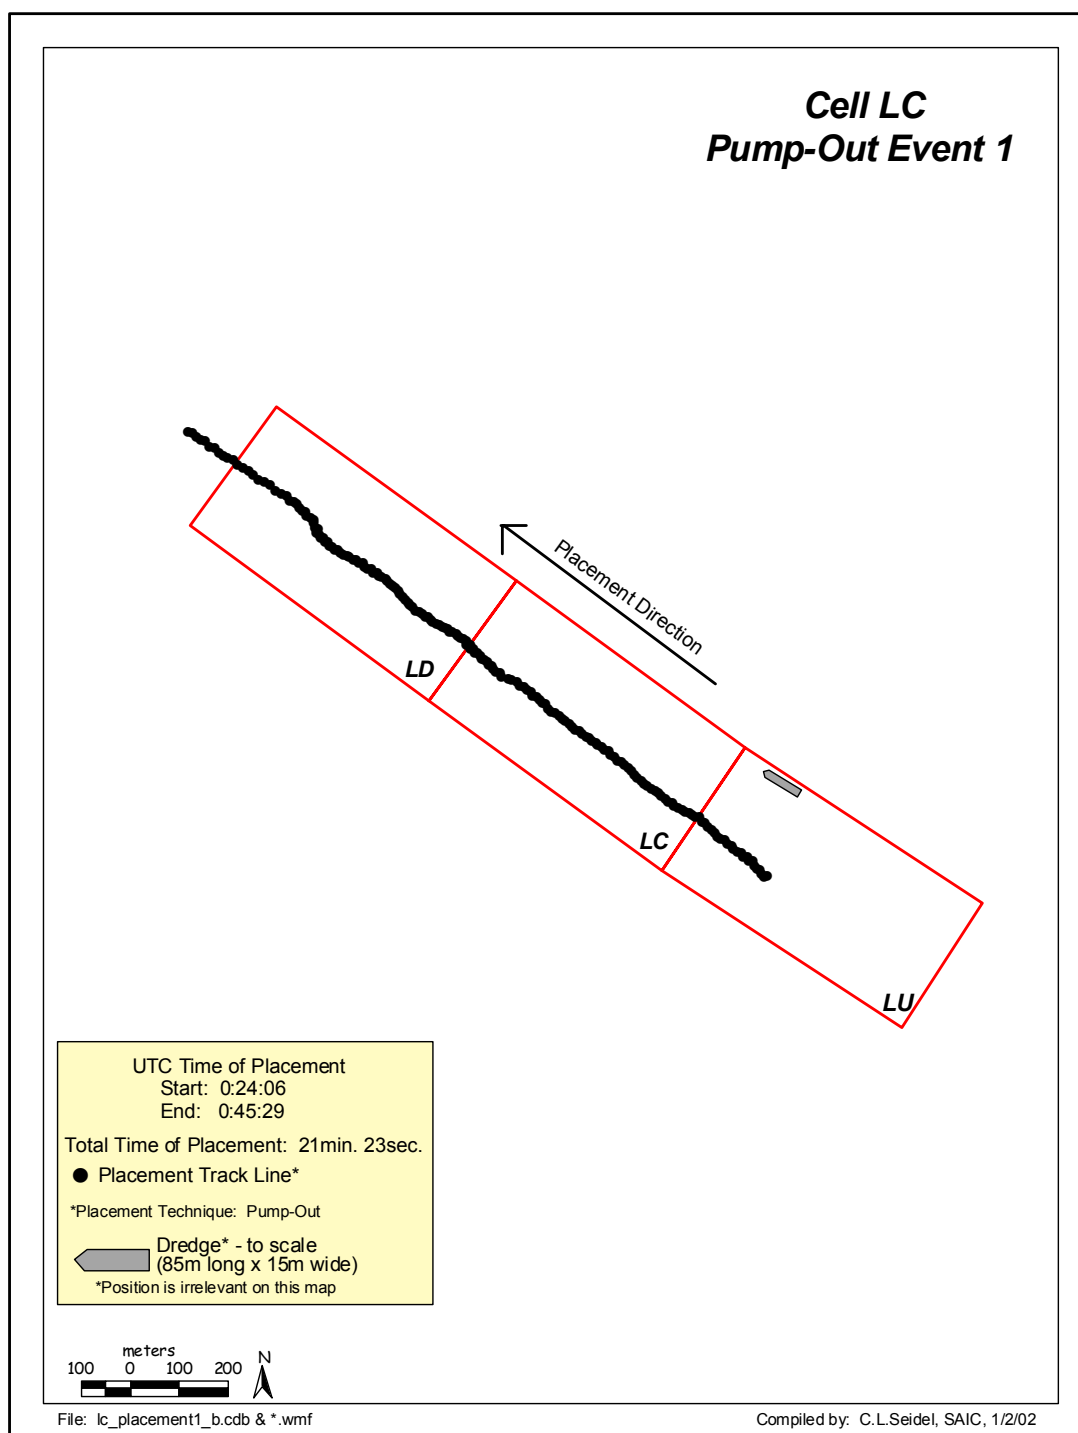
Figure 6.2-1. Map illustrating cells LU, LC and LD on the Palos Verdes Shelf and the trackline of the hopper dredge *Sugar Island* as it traveled northwestward along the axis of the cells during pump-out Event 1 on September 9, 2000. Dredge position data were acquired by ADISS.

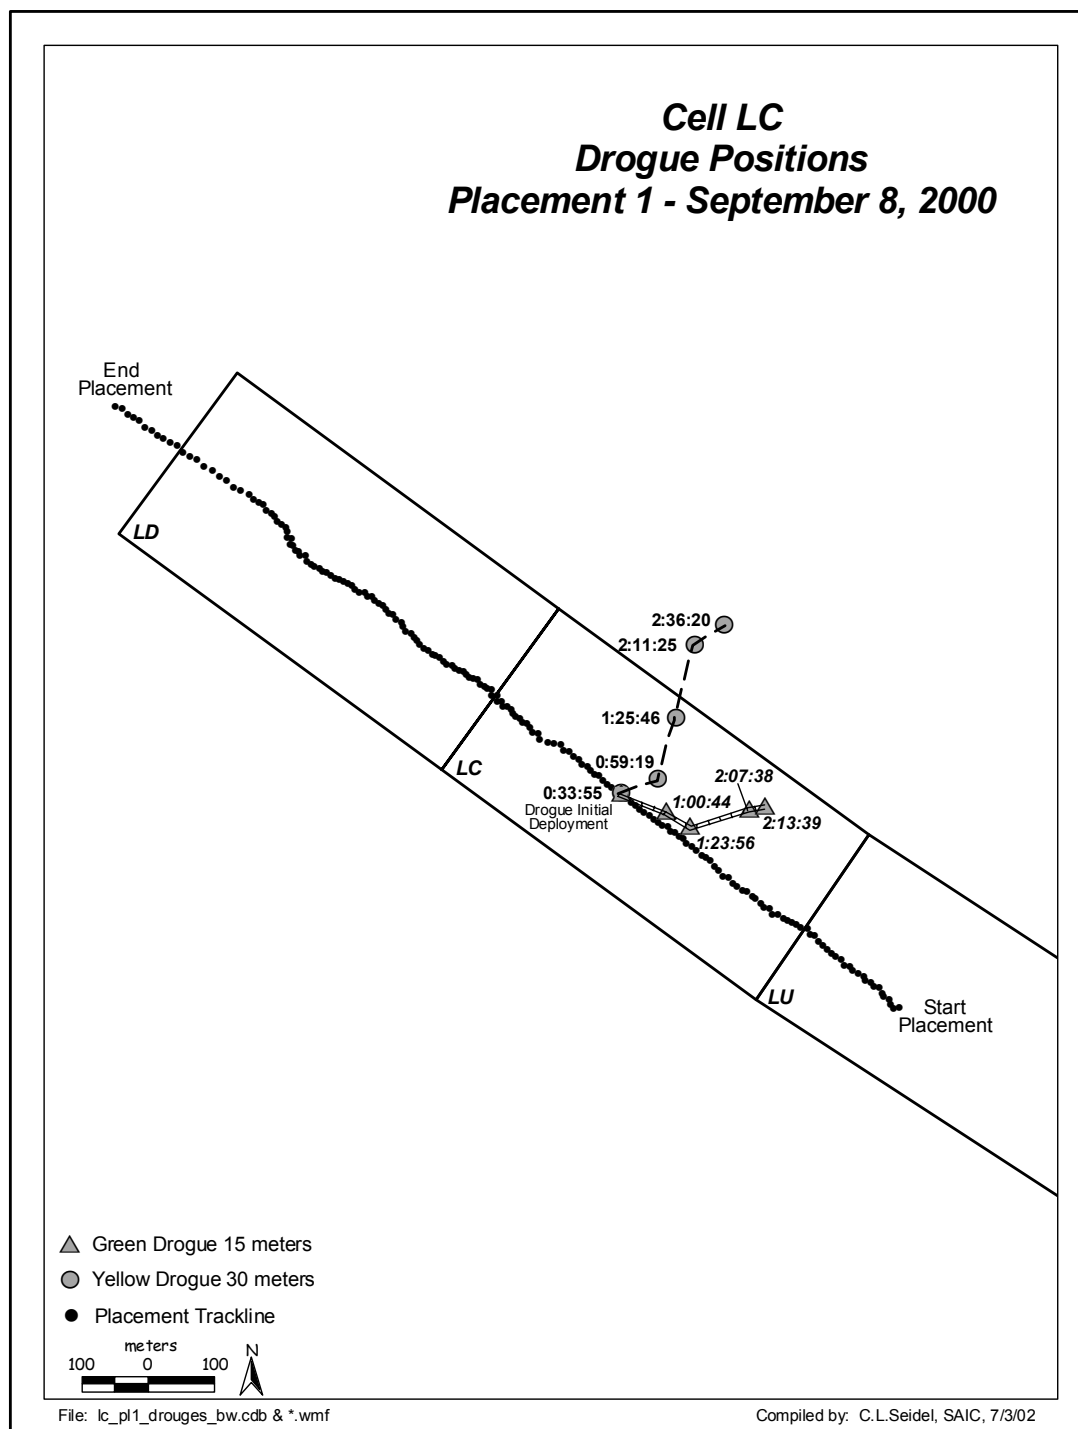
Figure 6.3-1. Map of Cell LC indicating trajectories of two drogues during water quality monitoring of placement Event 1 in Cell LC on September 8, 2000.

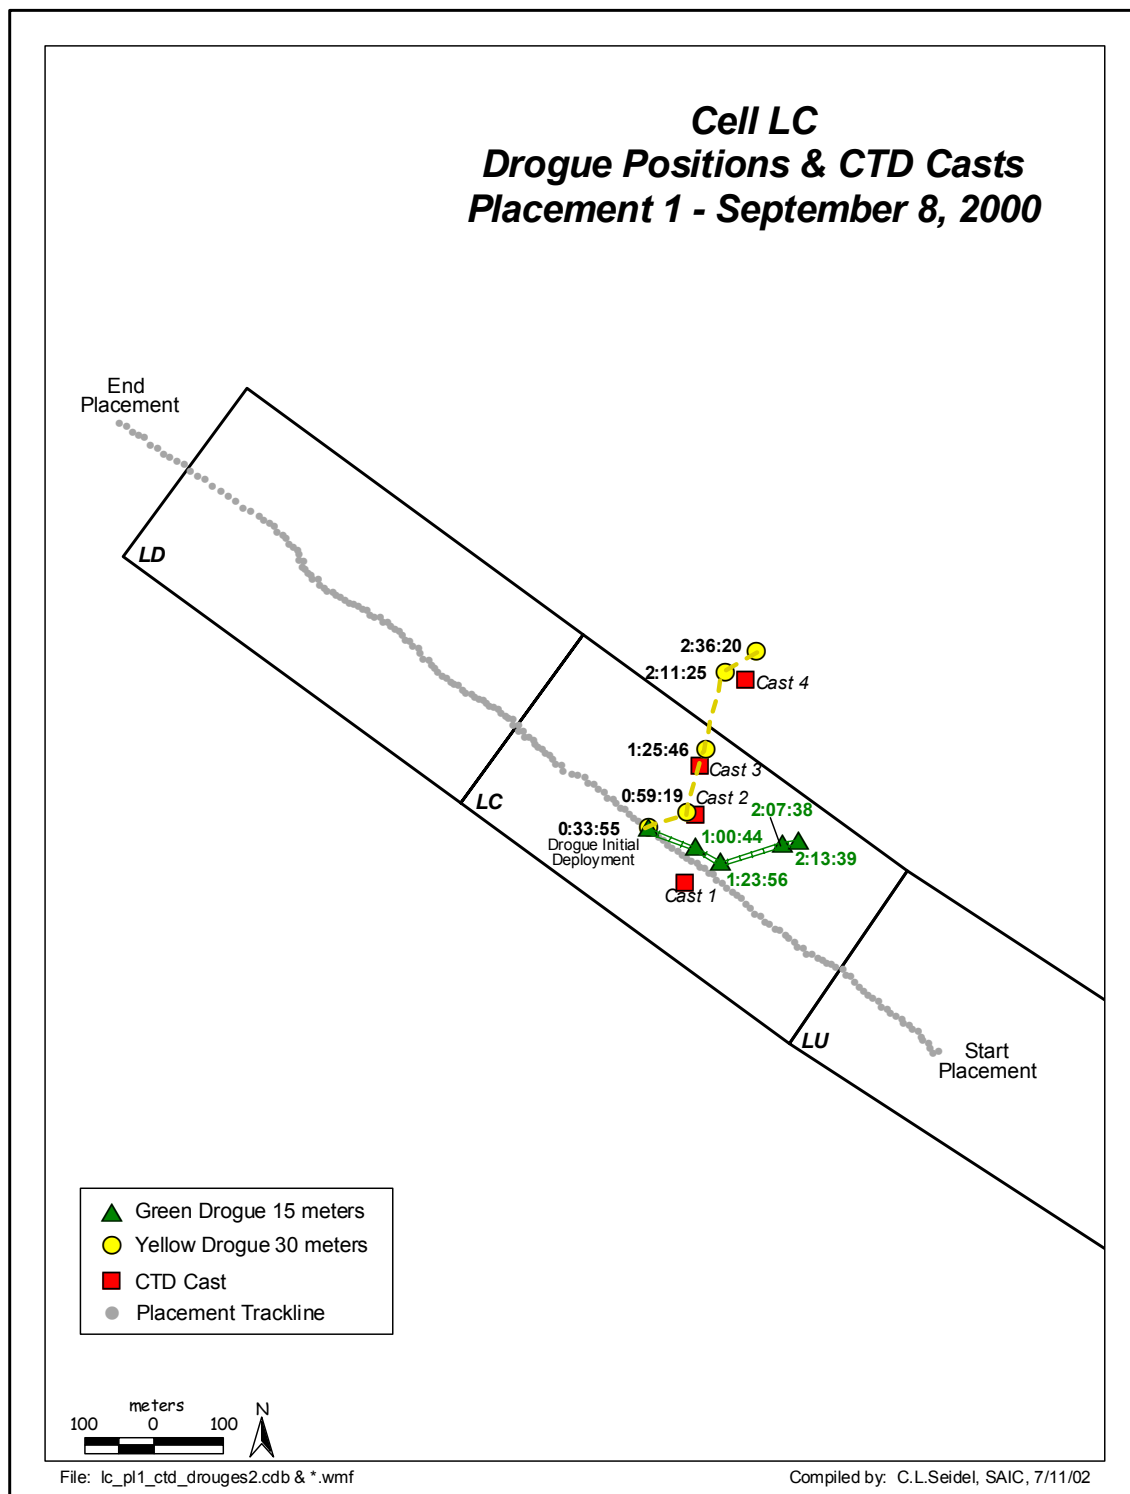
Figure 6.4-1. Map of Cell LC indicating drogue trajectories and CTD stations during pump-out Event 1 on September 8, 2000.
